**UPPER PATUXENT RIVER WATERSHED RESTORATION ACTION STRATEGY (WRAS)
FORM 1 -- Catchment Information**

UPPER PATUXENT RIVER WATERSHED RESTORATION ACTION STRATEGY (WRAS) FORM 2 -- Site Information

Site Name: Laurel Vol. Fire Dept. Station 10 Address: 7411 Cherry LaneSite Owner: Prince Georges CountyState Plane Coordinates of Site Centroid: X: 1347268 Y: 519659 Date: 3/21/03Personnel: JA, PM Weather: overcast, 55F degArea (ac): 5.8 Impervious Area (ac): 1.8Percent Impervious: 31% Soil Recharge Factor (S): 0.12WQ_v (required): 0.16 Re_v (required): 0.02Property Area (ac): 5.8 Property Area Included in Site: 100 %Amount of Catchment Occupied by Site: 26 %

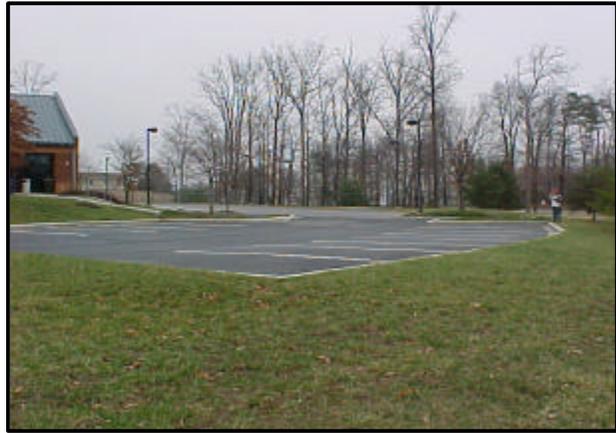
- No. 380 Description: looking at east side of building
- No. 381 Description: looking at south side of building
- No. 382 Description: looking at east side of property
- No. 383 Description: new parking additions (drained to curb cut)
- No. 384 Description: islands on west side of building
- No. 385 Description: looking at gravel that drains sheet flow from roof
- No. 386 Description: south side of building looking west
- No. 387 Description: north side of building looking west
- No. _____ Description: _____
- No. _____ Description: _____
